Manhole Inspection Summary

Manhole # S41A__037MH

Location Address: **N.Central Ave.**

Cross Street: **Orleans St.**

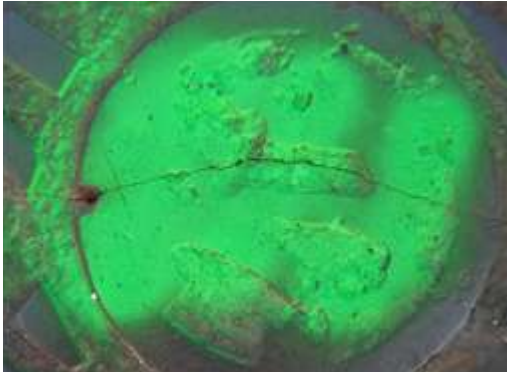
Defect 8

Condition: **Cracked**

crack in MH Cover

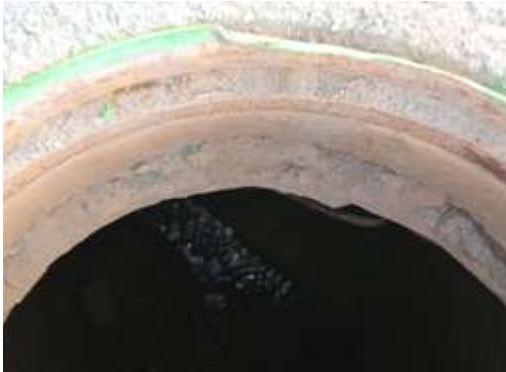
Defect 7

Offset: **2** (in.)

Condition: ☐ Sound ☒ **Cracked** ☐ Leaks

frame chipped/cracked & offset

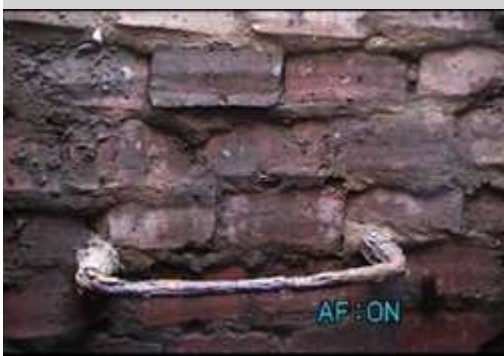
Defect 5

Count: **6** Missing: **0** ☒ **Corroded**

corroded rung and corbel infiltration from mortar

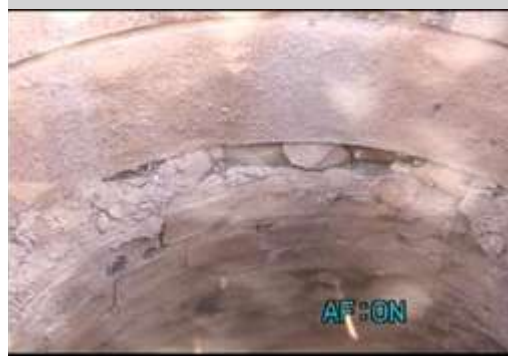
Defect 4

Condition: ☐ Sound ☐ Cracked ☐ Root Intrusion ☐ Loose Brick ☒ **Deteriorated**

deteriorated chimney

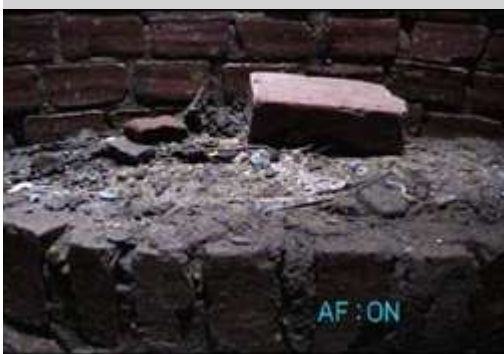
Defect 2

Condition: ☐ Sound ☐ Cracked ☐ Root Intrusion ☐ Deteriorated ☐ Leaks ☒ **Debris**

debris on the bench

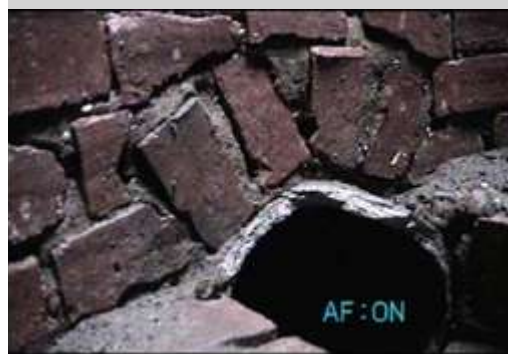
Defect 1

9 o'clock pipe seal cracked

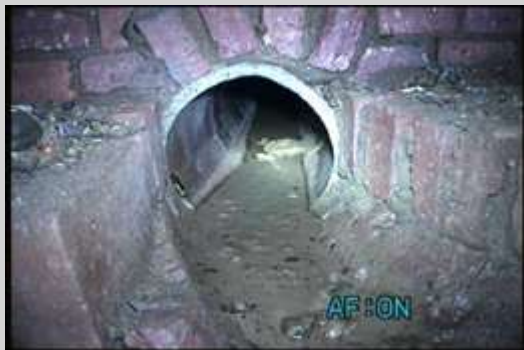
9 O'Clock Inflow

Infiltration: **None** Pipe Seal Cond: **Cracked**
